INVESTIGATION OF MOTOR-VEHICLE CRASHES INVOLVING WHEELCHAIR-SEATED OCCUPANTS

Lawrence W. Schneider, Jamie L. Moore, Joel B. MacWilliams
The University of Michigan Transportation Research Institute
2901 Baxter Road Ann Arbor Michigan 48109

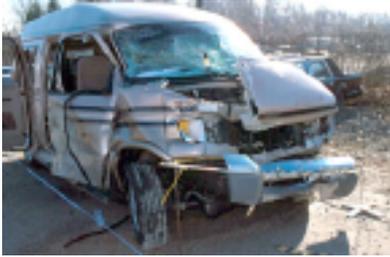
Case 1 – Offset-Frontal Crash of Full-Size Van with Adult Passenger in a Power Wheelchair
In this crash, the right front of a 1998 Ford Econoline van struck the box of a 1997 Chevy dump truck after the truck entered a four-way intersection from the north. Figure 1 shows the damage to the van, which was estimated to correspond to a 20-mph delta-V offset-frontal

Figure 1 - Damage to front of Econoline van carrying a wheelchair-seated passenger.

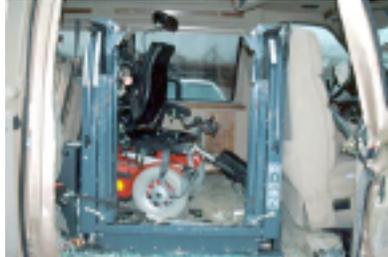
impact. A 28-year-old male passenger was seated in a 300-lb powerbase wheelchair that was equipped with four securement points that had been crash tested as specified in Section 19 of ANSI/RESNA WC/Volume 1 (1), and secured facing forward just behind the front seats using an SAE J2249-compliant (2) four-point strap-type tiedown, as shown in Figure 2.

Figure 2 - Powerbase wheelchair secured by four-point strap-type tiedown behind front van seats.

Although the wheelchair rider was not using an available vehicle-anchored three-point belt, this case is considered to be a transit-wheelchair/tiedown success story because the wheelchair occupant sustained only minor injuries in a moderate offset-frontal crash due to the fact that his heavy wheelchair was effectively secured by a J2249-compliant tiedown system attached to crash-tested securement points. Although the postural belts offered nearly sufficient restraint in this 20-mph frontal crash, it is likely that the wheelchair occupant would have been seriously or fatally injured if the crash had been more severe. Had the wheelchair rider been using the available three-point belt restraint, he probably would not have sustained the head laceration or fractured finger in this crash.

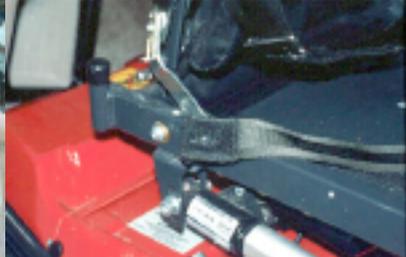
Figure 3 - Postural lap belt torn at attachment to wheelchair.

Prior to the crash, the wheelchair occupant was restrained in the wheelchair by lap and chest postural belts that were attached to the wheelchair frame using sheet-metal screws through webbing grommets. As indicated in Figure 3, the lap belt failed first due to occupant loading at the right attachment point, followed by failure of the chest belt at the left attachment point to the seatback (not shown). These failures allowed the wheelchair occupant to slide out of the wheelchair during the impact, resulting in a laceration to the back of the head from contact with the wheelchair and a fracture to the second finger of the right hand, probably from contact with the right-front passenger seat.

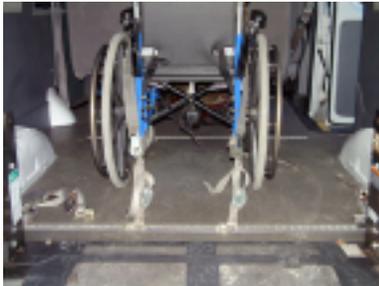
Figures 4 and 5 show the case occupant's wheelchair secured in an exemplar van with an adult occupant restrained by the three-point belt. Figure 6 shows the location of the lap-belt buckle

Figure 4 – Rear view of manual wheelchair secured by four-point strap tiedown at rear of van.

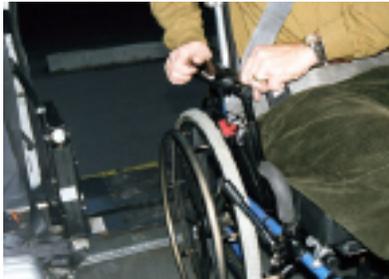
Figure 5 – View of three-point belt showing location of end-release button on receptacle.

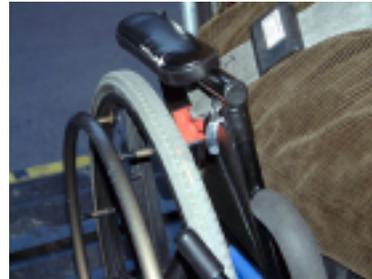
receptacle with end-release button relative to the wheelchair side frame and large right wheel, and shows the reason that this belt-restrained wheelchair user was ejected in a rollover crash. As the vehicle rolled to the right, the wheelchair and occupant leaned to the right, causing the buckle receptacle to move downward relative to the large wheel rim. As the vehicle completed the first 360-degree roll, the wheelchair and occupant leaned back to the left, causing the buckle receptacle to move up into contact with the large wheel rim, depressing the end-release button and releasing the buckle tongue from the buckle receptacle. Because the shoulder belt attaches to a pin-bushing connector on this restraint system, release of the lap belt buckle also released the shoulder belt, and the occupant became completely unrestrained, thereby allowing his ejection from the vehicle.

Figure 6 – Closer view of buckle receptacle between large wheel and armrest.

In-depth crash investigations of motor-vehicle crashes provide accurate information on real-world injury scenarios that are unique to wheelchair-seated occupant, and can reveal problems that have not yet been addressed by existing standards and transportation procedures. This is illustrated by the two cases presented in this paper. Case 1 is primarily a success story that illustrates the value of using a crash-tested *transit* wheelchair. While this case illustrates how postural belts can provide some restraint in frontal crashes, it also points out the potential limitations of postural restraints in more severe crashes. Case 2 illustrates the problems that current wheelchair structures present to effective performance of vehicle-anchored belt restraints that comply with SAE J2249 and federal safety standards.
